Fire Extinguisher Explosion on DZ 28

Friday Nightshift 7th May 2010

D Crew

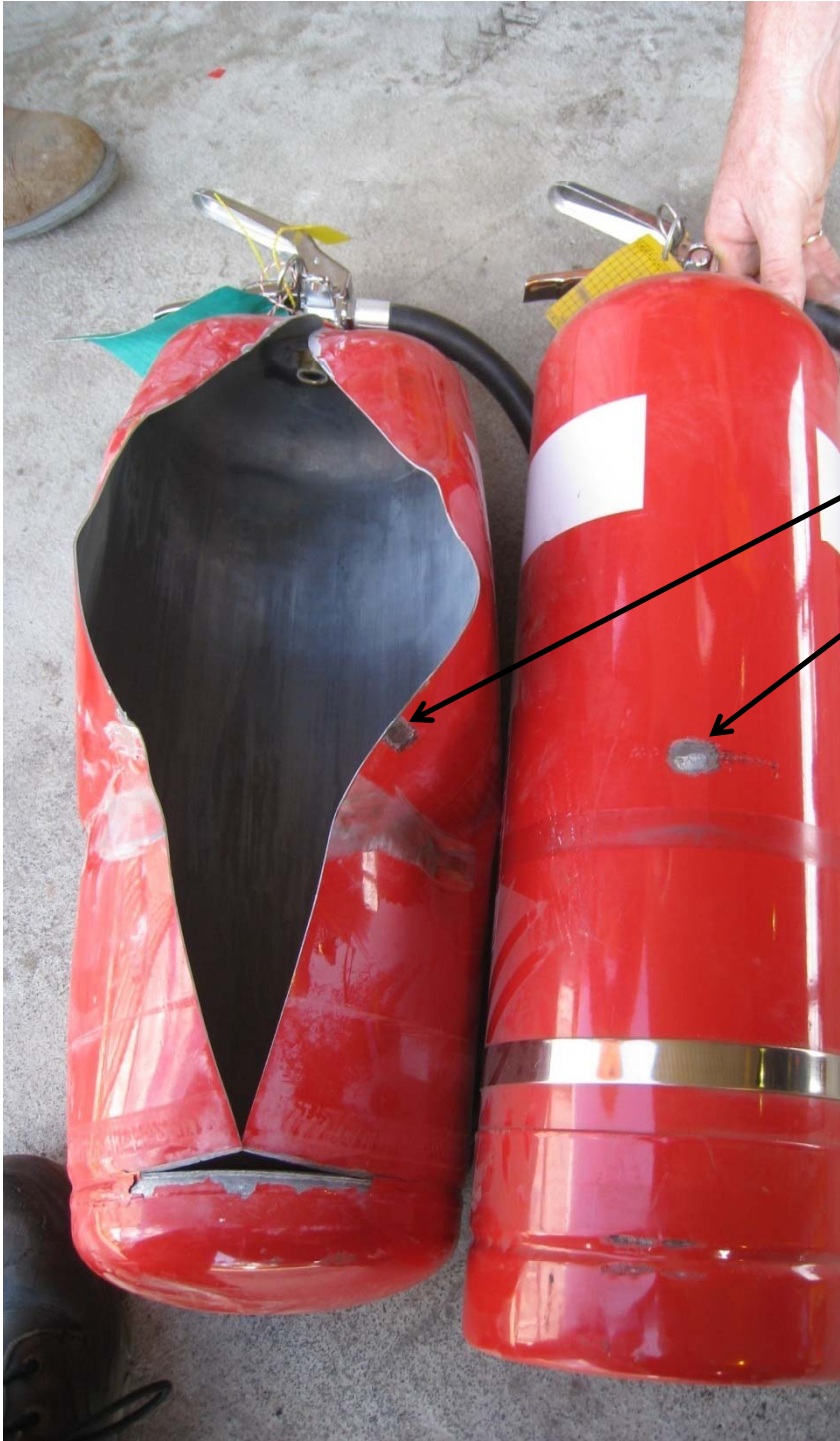
Bracket bolt head appears to have created wear area resulting in fatigue cracking

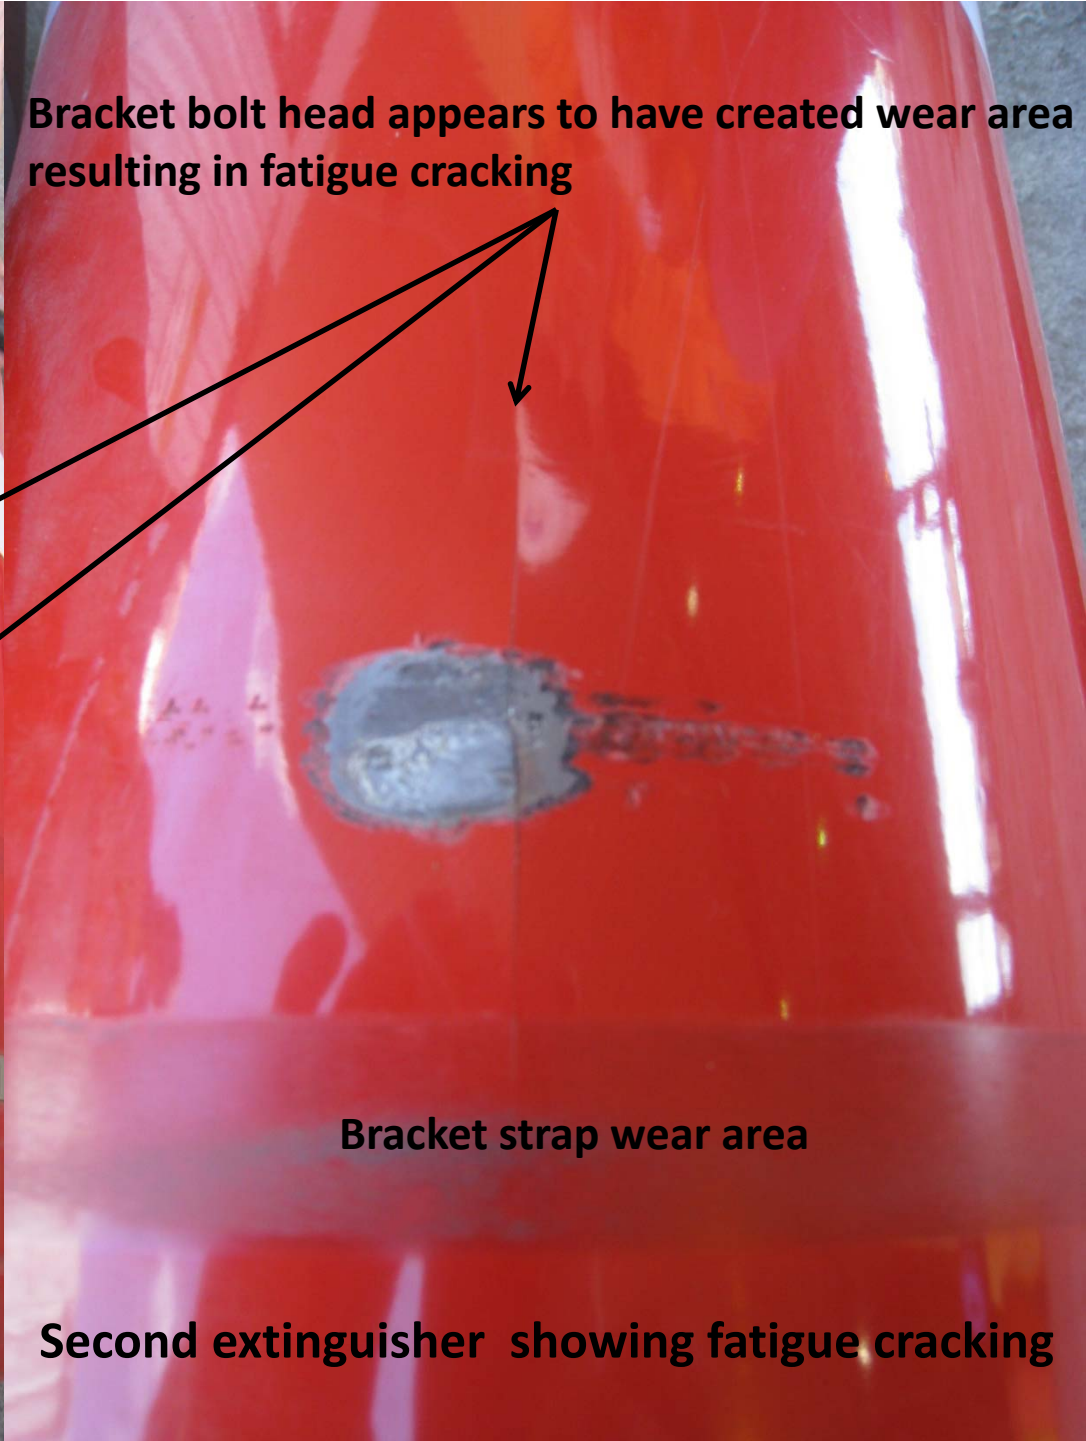
Bracket strap wear area

Second extinguisher showing fatigue cracking

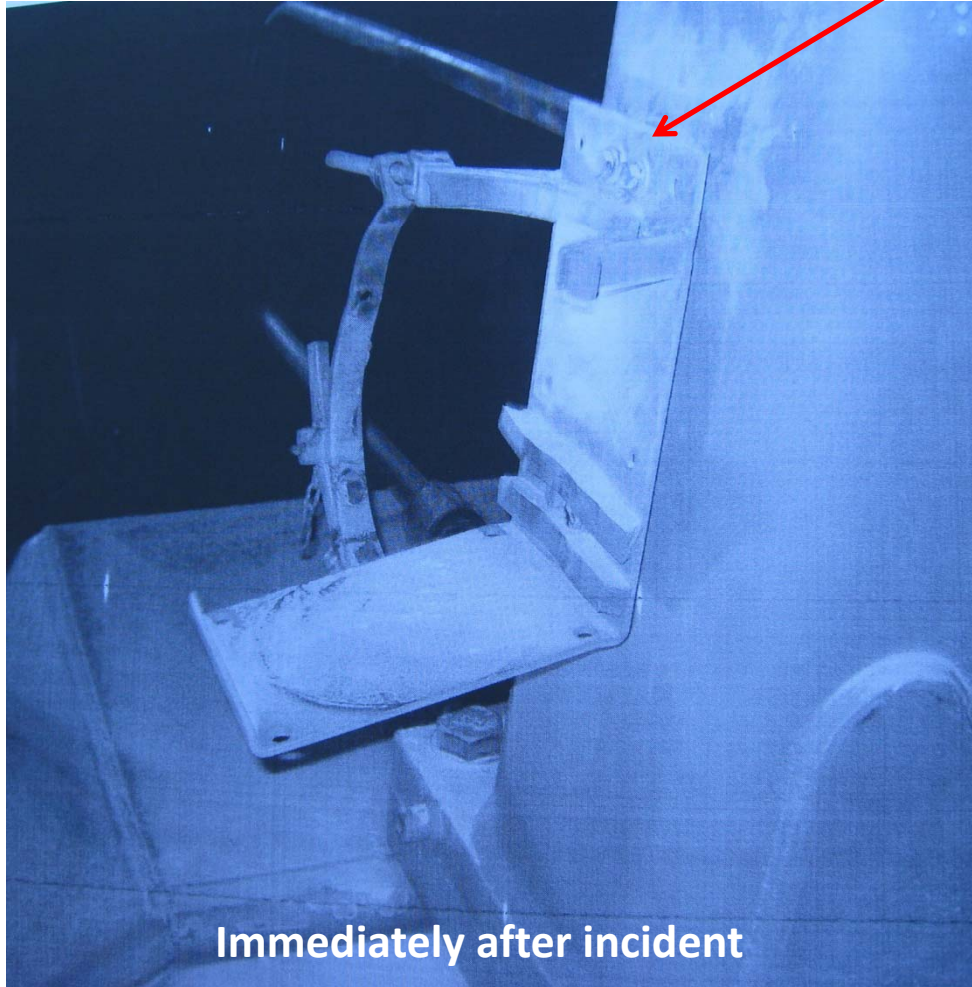
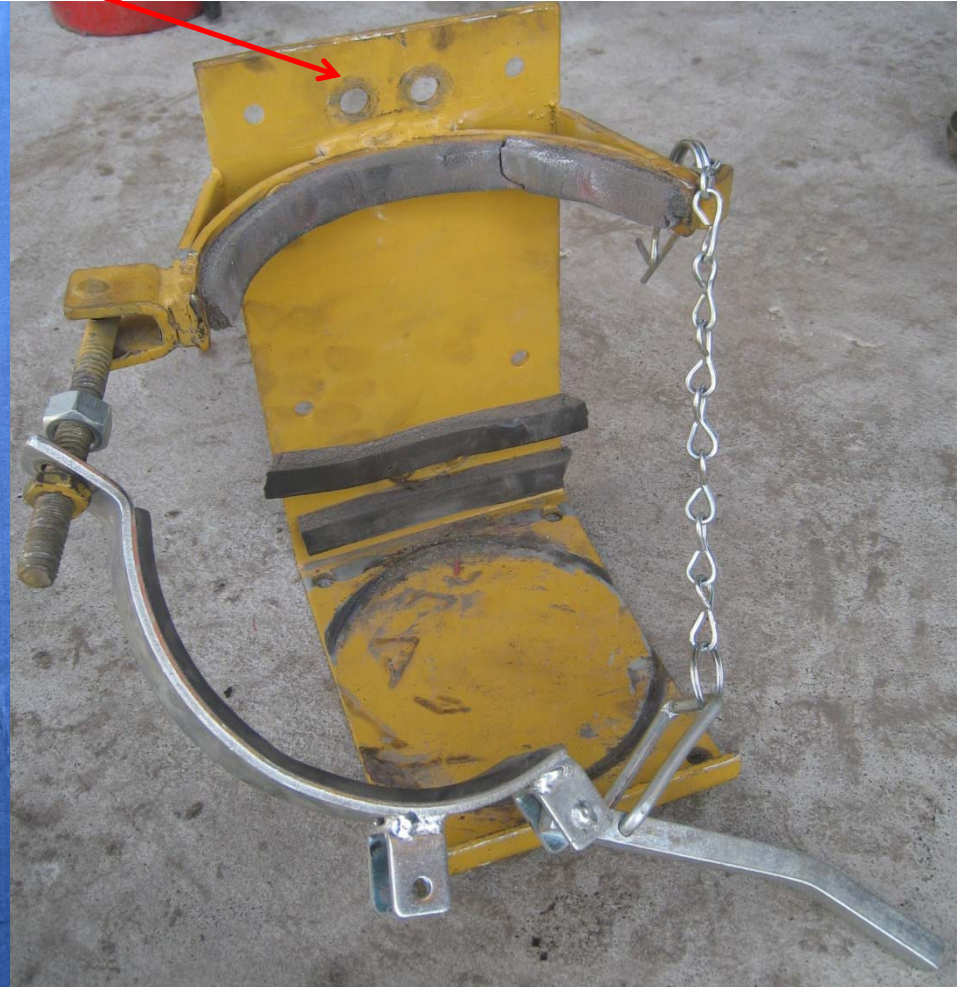
Actual Bracket Involved

Arrows point to bolt location

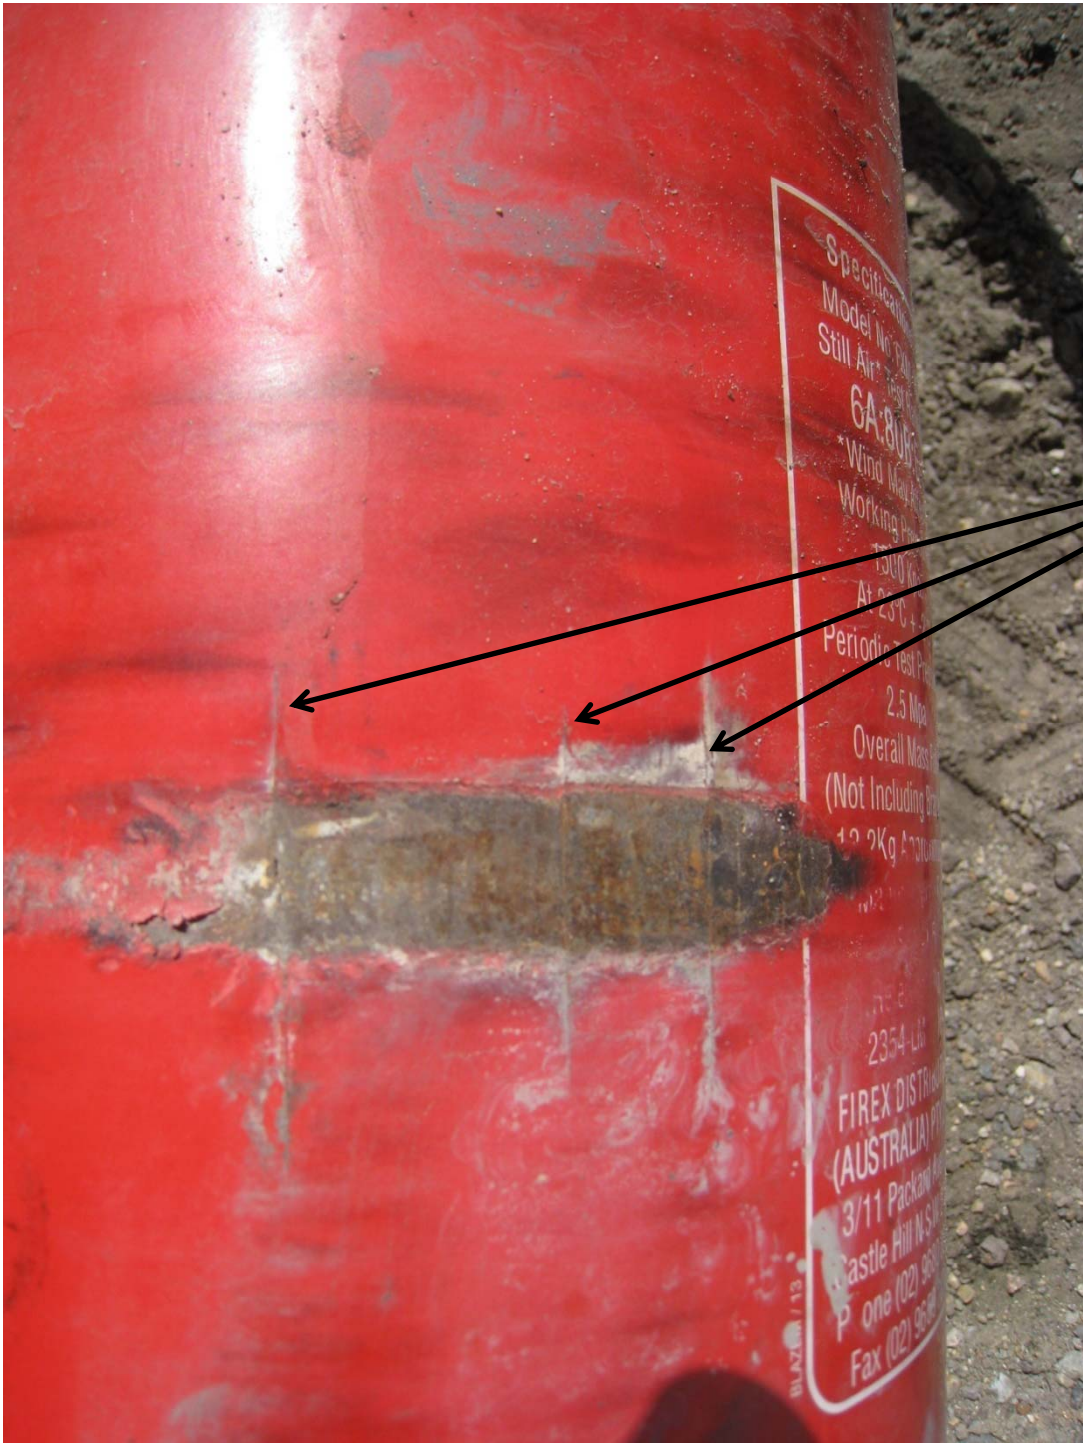
Fatigue cracking

Third extinguisher showing wear from bracket strap rubbing

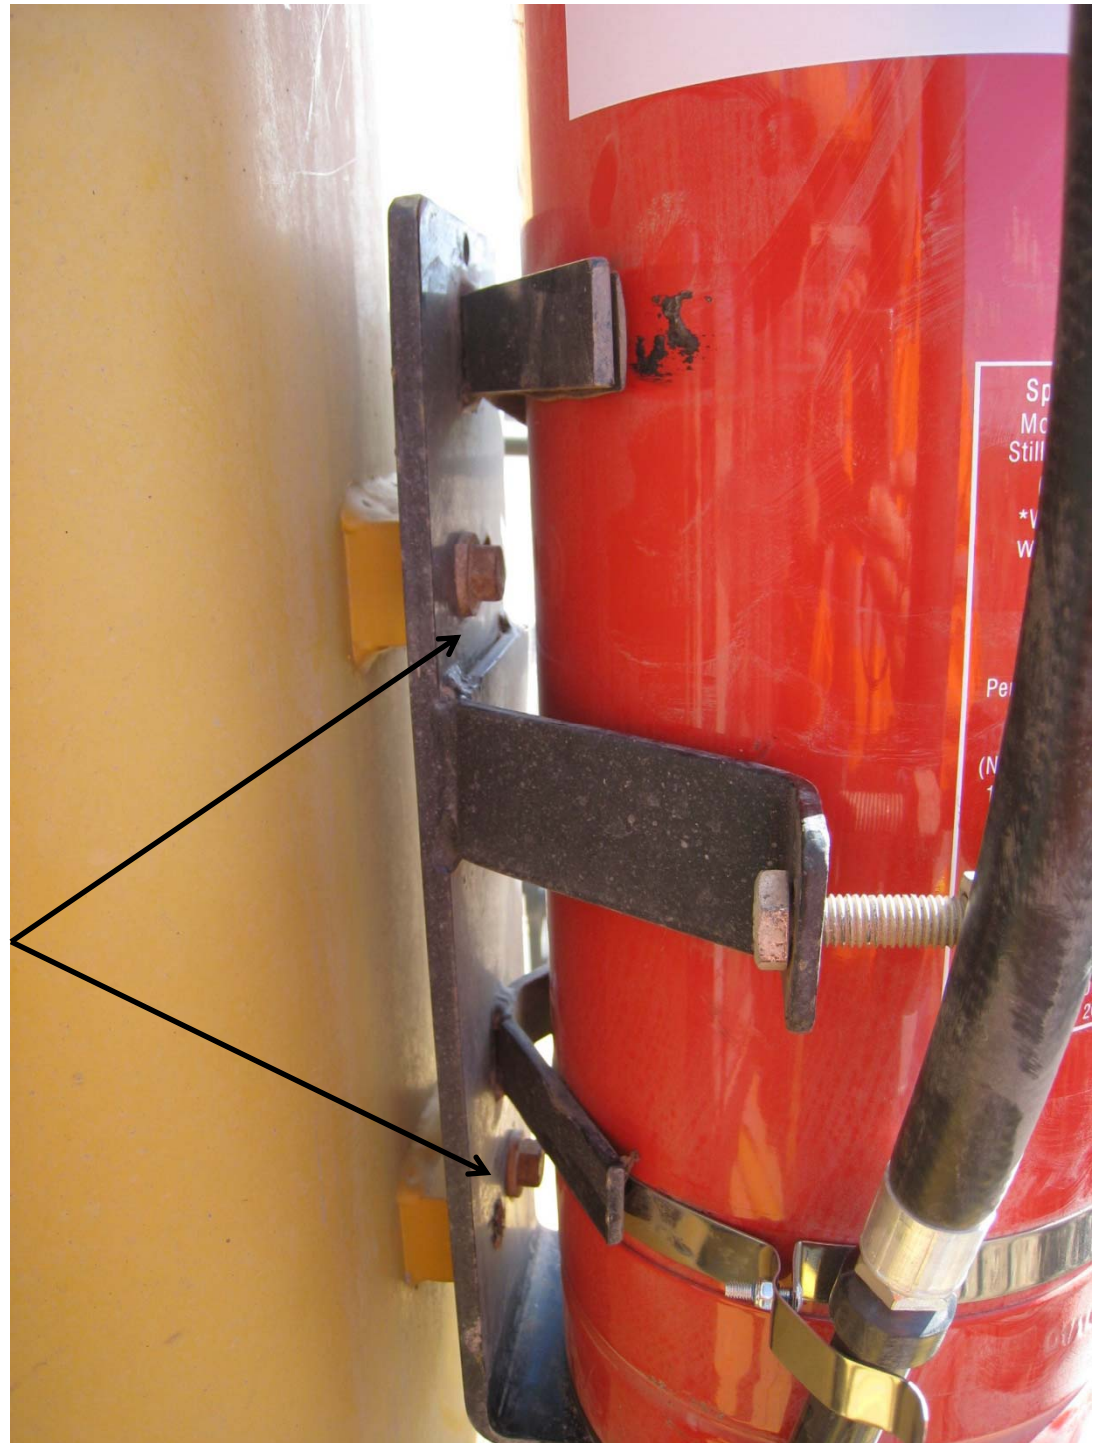
Alternate bracket design showing
adequate gap between bolt heads and
extinguisher

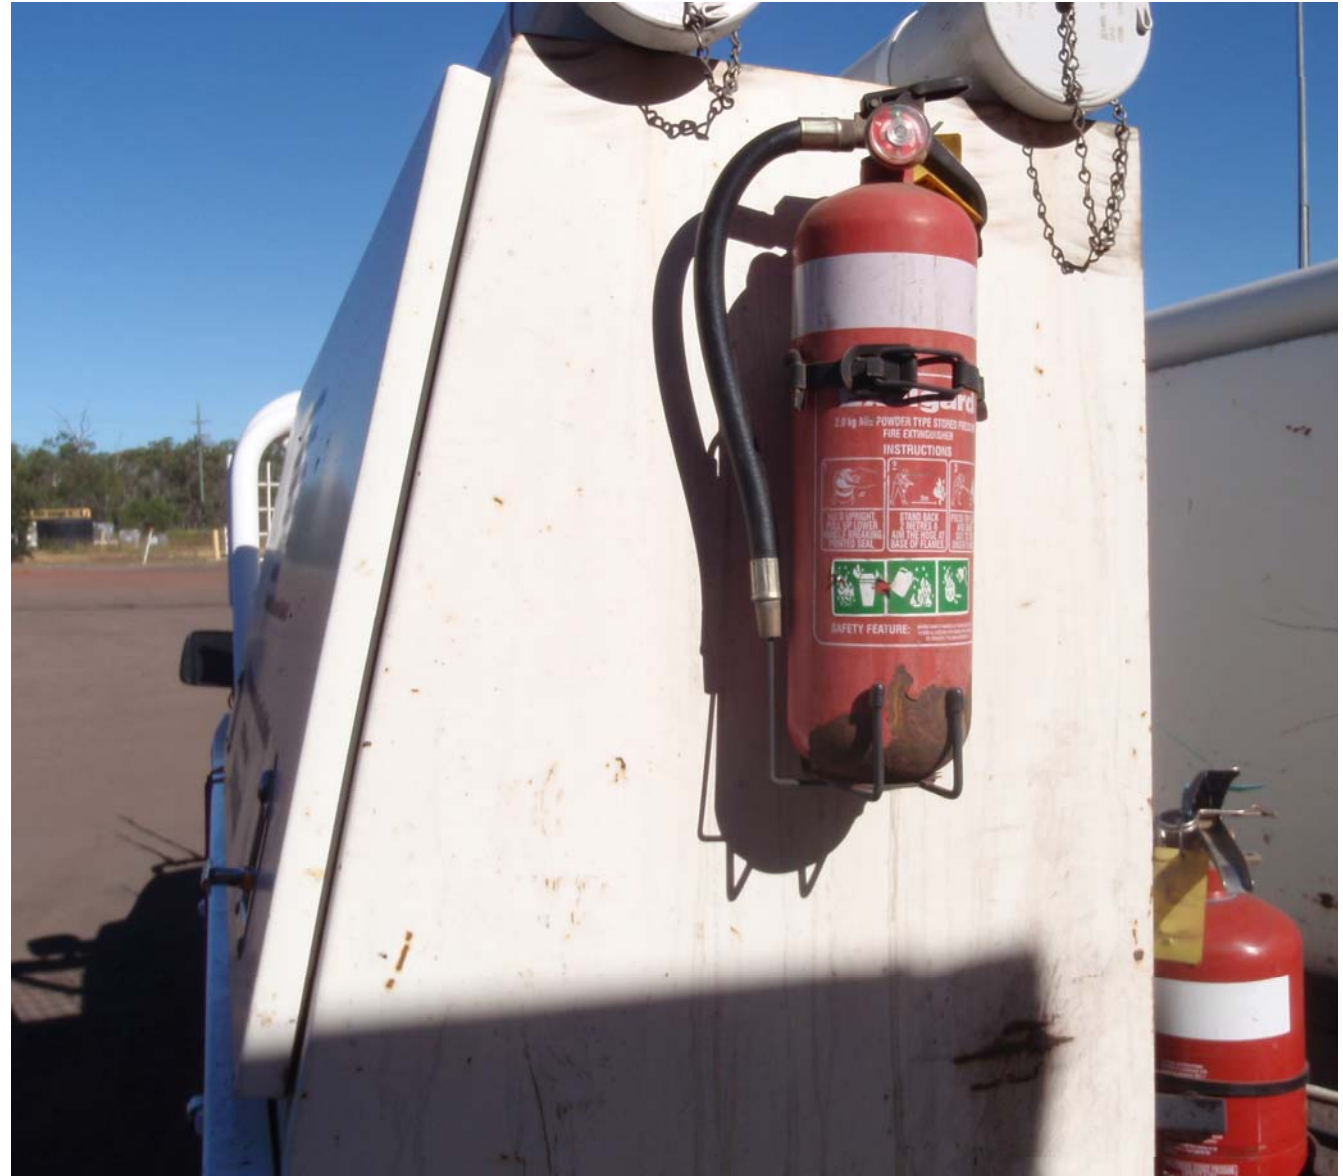
Burton – Checks
found this FE with a
corroded base –
another potential
bomb!
